Hot water heater in school kills seven

What follows is an extract from the fire journal report on an incident that took place at the Star elementary school in 1982.

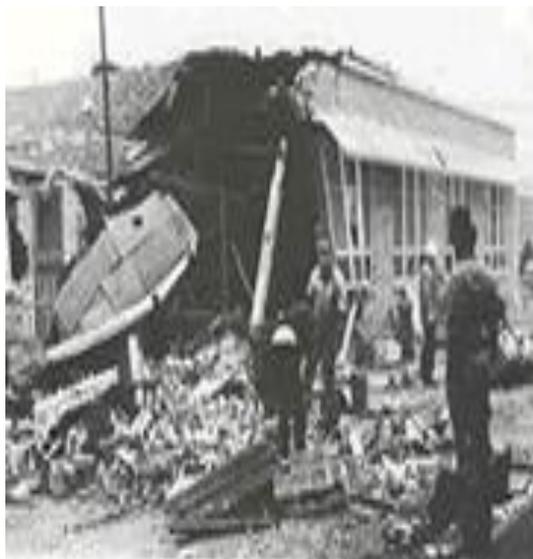
A malfunction of an 85-gallon hot water heater occurred during a lunch period at the Star Elementary School in Spencer, Oklahoma, on January 19, 1982. One corner of the cafeteria was destroyed by the explosion and pieces of concrete block were thrown across the lunchroom. Six children and one teacher were killed and 33 others suffered injuries of varying degrees. The malfunction was caused by overheating of the water in the tank and lack of emergency temperature-relieving capability.

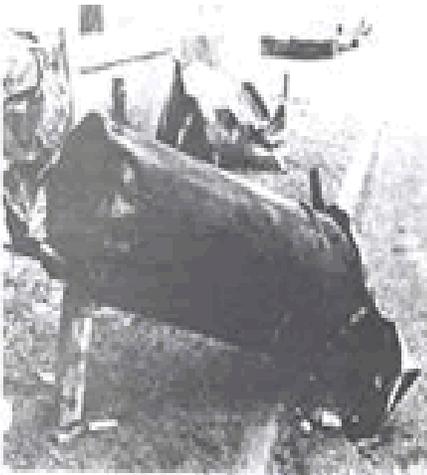
The pressure and additional temperature-relief protection for the exploded tank was a combination pressure and temperature-relief valve (commonly called "T&P relief valve") in a common housing. After close examination, the investigators determined that the temperature-sensing element had been removed, leaving the T&P valve with no temperature-relief capability. They further discovered that the relief valve had been improperly installed, using a 45° elbow fitting which would have made it impossible to install the valve with the temperature-sensing element in place and properly projecting into the upper six inches of water in the heater.

The continuous build-up of heat from an uncontrolled burner with no emergency temperature-relief capability resulted in a water temperature above 212°F (i.e. superheated water). When the tank failed, a portion of the superheated water instantly expanded to steam, creating the thrust that propelled the tank pieces and the shock-wave effect identified as the blast, or explosion. Other factors that had some bearing on the accident, either directly or indirectly, were reported by the Fire officer:

The accident demonstrates the need for a means to prevent temperatures above 212°F in water heaters, because a hazard does not exist if the liquid in a container is at a temperature below its normal boiling point. The missing temperature-relief element, set at 210°F, in the temperature-pressure relief valve would have been one such means. Without this, the high temperature thermostat in the control circuit for the automatic valve was the only such means in place. This was intended to close the valve when the temperature reached 210°F. However, it failed -apparently due to corrosion.
